Franconia 24497 Lafayette Brook Bridge Cultural Resource Meeting #2

NH 18 over Lafayette Brook June 11, 2015

About the Bridge

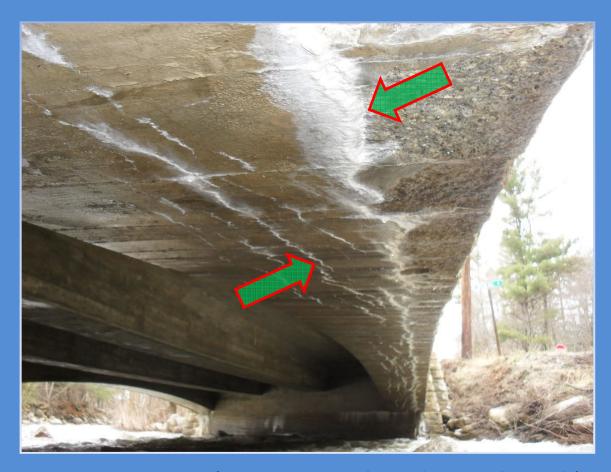
Upstream Exterior T-Beam Cracks and Leaking

Explained that the existing bridge superstructure had reached the end of its service life and must be replaced, however ...

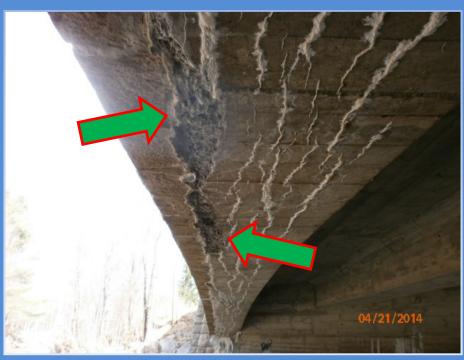
Downstream Exterior T-Beam Spalling and Leaking

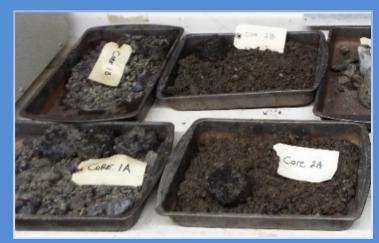
Poor Quality Concrete Cores

Intact Core

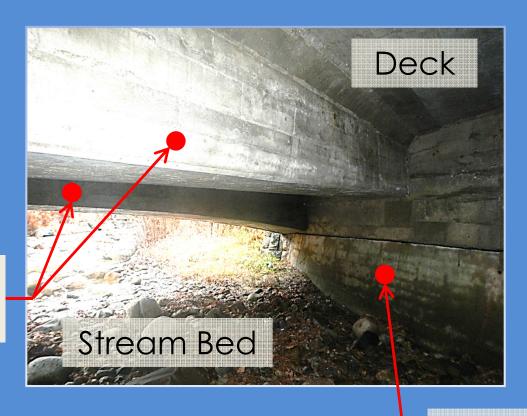
The abutments and wingwalls were in good condition and could be rehabilitated

Concrete T-Beam

Abutment

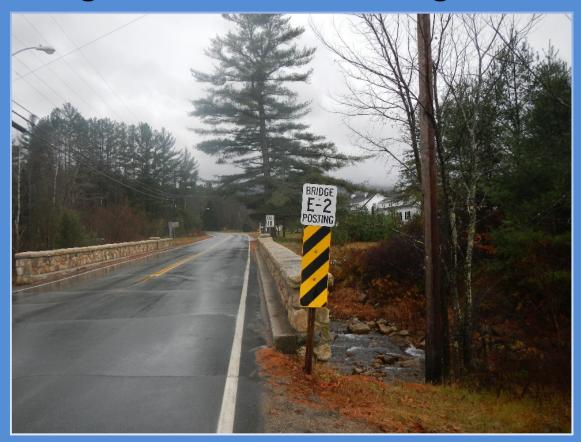
Intersection Sightlines

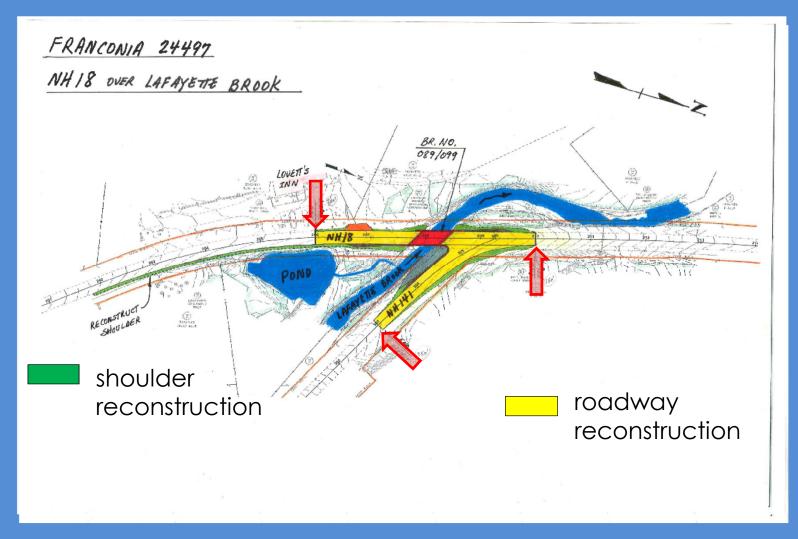
Site Plan - Approximate Project Limits

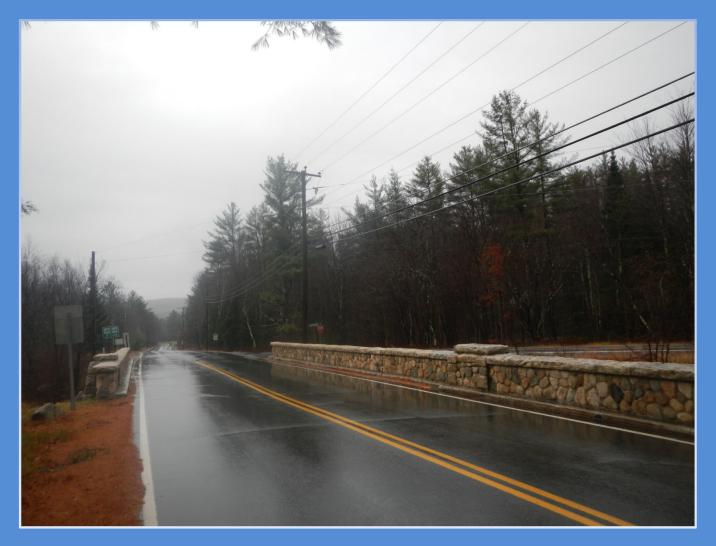
- Provide a concrete parapet railing with architectural treatment on faces – consider exposed aggregate finish
- Salvage existing cap-stones and reset on the new parapet railing
- Retain existing stone-faced pilasters

Existing Bridge – Stone Parapet Rail

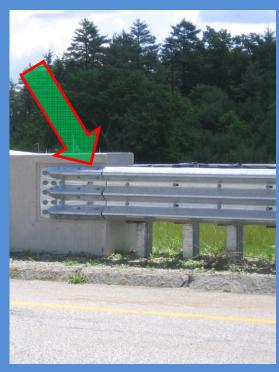
Transition to Barrier or Parapet

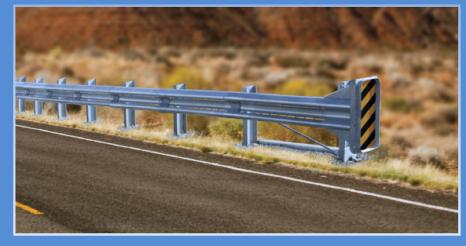
Energy Absorbing End Unit

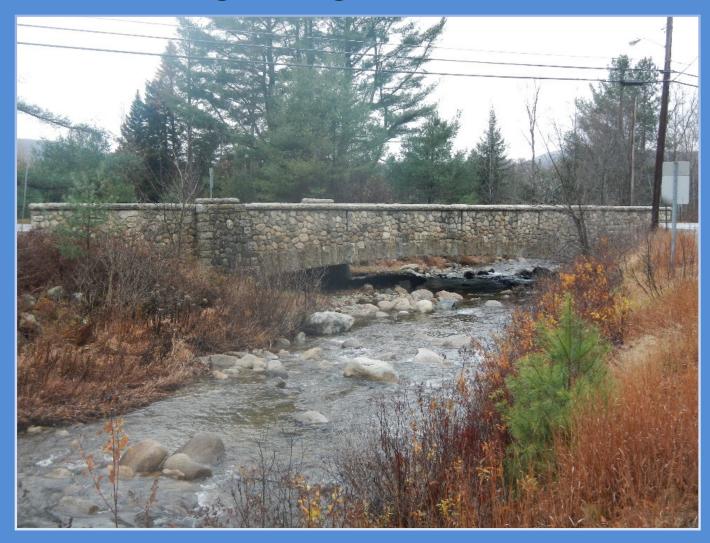
Existing Bridge - Elevation

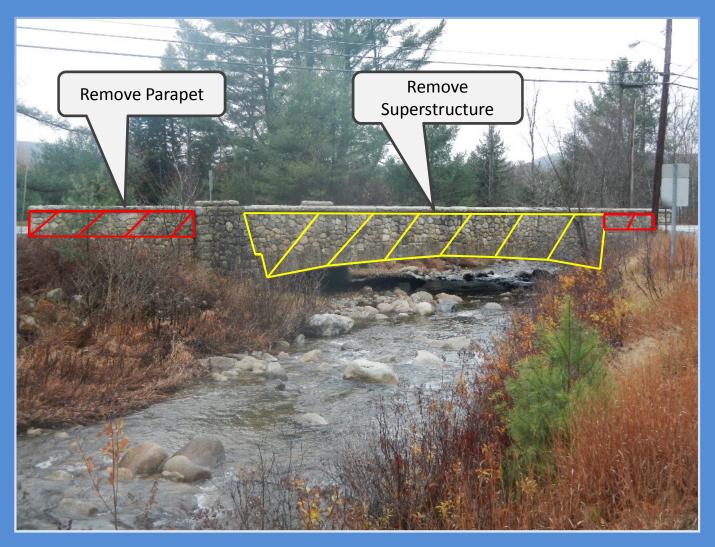
Proposed - Removal

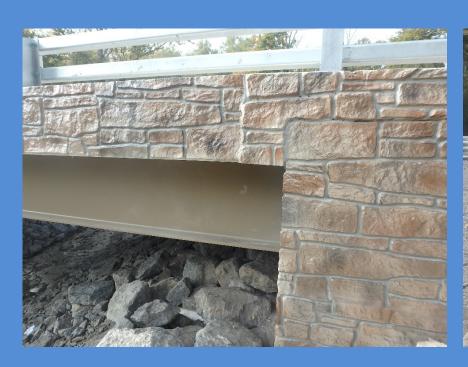
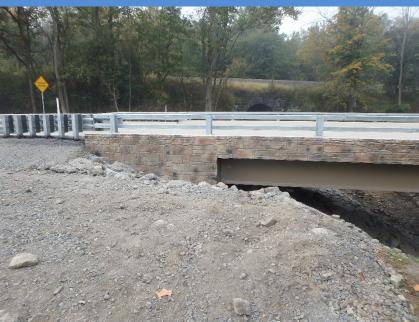
Stained Concrete Form-liner SAMPLE

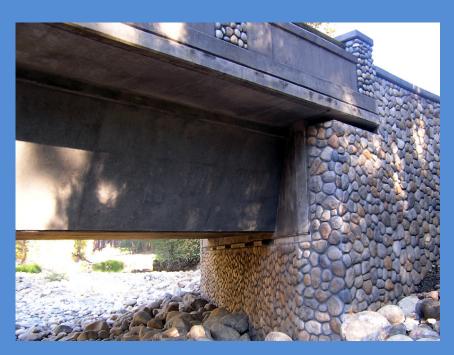
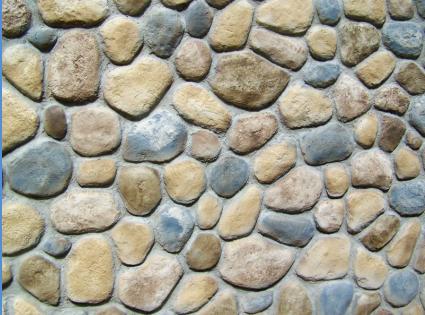
Stained Concrete Form-liner SAMPLE
